PHOTOGRAPHIC SURVEY OF THE LDEF MISSION

NASA Special Publication 531

Robert L. O'Neal

National Aeronautics and
Space Administration

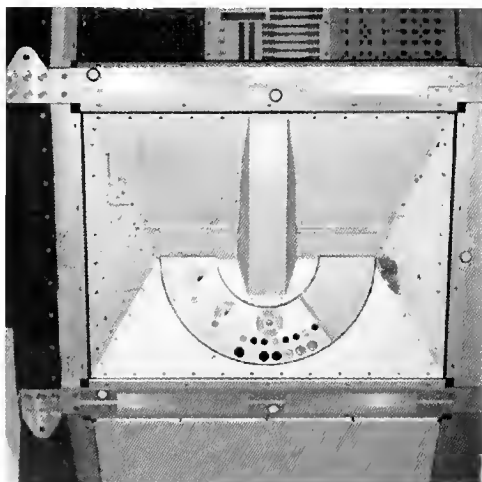
Figure 121
Photo No.: KSC-390C-1030.11
Dup. Neg. No.: L90-13409
LISAR No.: EL-1994-00144
Photo Credit: KSC
Photo Date: 2/9/90
Location: KSC SAEF 11
Subject: Postflight Survey of Tray A9

Figure 121 (Postflight). The 2-mil silvered Teflon film surface on the shroud appears to be the same as in flight. It is white with brown discolorations in a distinct pattern. The left and right triangular sections of the shroud have many irregular black discolorations and areas where the adhesive appears to have failed.

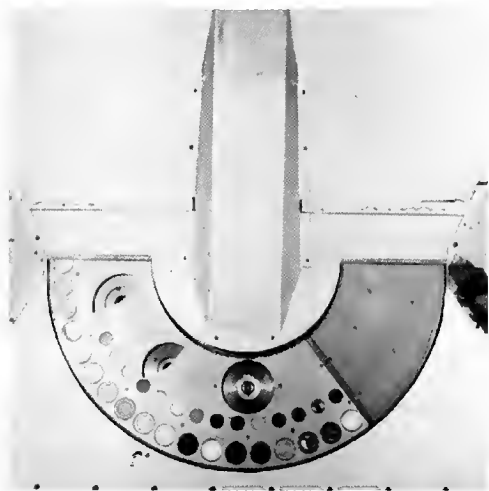
Figure 122
Photo No.: KSC-390C-1419.03
Dup. Neg. No.: L91-7715
LISAR No.: EL-1994-00375
Photo Credit: KSC
Photo Date: 2/28/90
Location: KSC SAEF II
Subject: Postflight Detail of Tray A9

Figure 122 (Postflight). This close-up photograph is of the carousel and test specimens. Note the discoloration streaks on the silvered Teflon film in the upper portions of the photograph and the evidence of numerous small impact discolorations. While changes in color have occurred in both the active and passive test samples, they appear to be the same as in flight. The three radiometers seem to be without physical damage.

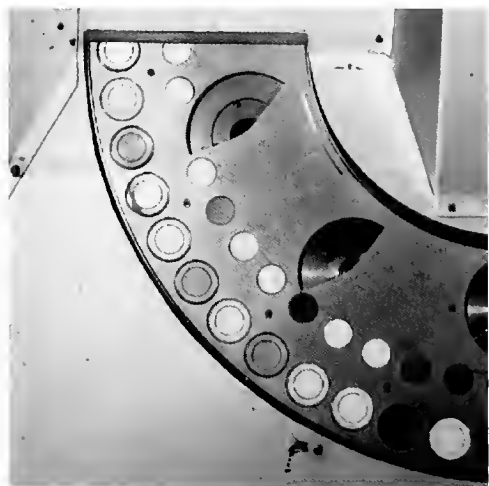
Figure 123
Photo No.: KSC-390C-1419.04
Dup. Neg. No.: L91-7716
LISAR No.: EL-1994-00376
Photo Credit: KSC
Photo Date: 2/28/90
Location: KSC SAEF II
Subject: Postflight Detail of Tray A9

Figure 123 (Postflight). This close-up photograph is of the left area of the exposed test samples. The calorimeter outer edge appears to be deformed in the fourth from top (outer) active sample location. The passive samples, located on the inner radius, seem to have no physical damage; however, some of the white paint samples now appear brown or tan. A point of space debris impact is located just off the edge of the carousel.

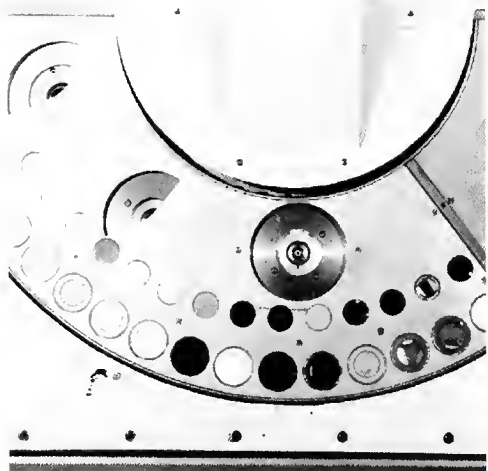
Figure 124
Photo No.: KSC-390C-1419.05
Dup. Neg. No.: L91-7717
LISAR No.: EL-1994-00377
Photo Credit: KSC
Photo Date: 2/28/90
Location: KSC SAEF II
Subject: Postflight Detail of Tray A9

Figure 124 (Postflight). This close-up is of the center area of the exposed test specimens. Some of the test specimens appear discolored and damaged. Note the first four from the right active coating samples, which are located on the outer radius. Two of the first three, which were originally white, now appear brown and have significant damage. The fourth active sample from the right, which was originally black, appears to have eroded, thus leaving only a trace of the paint or primer on the substrate. The passive samples, located on the inner radius, appear to have no physical damage; however, some of the white paint samples now appear brown or tan.

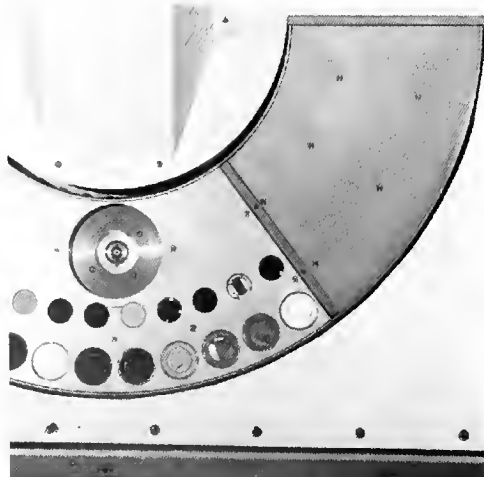
Figure 125
Photo No.: KSC-390C-1419.06
Dup. Neg. No.: L91-7718
LISAR No.: EL-1994-00378
Photo Credit: KSC
Photo Date: 2/28/90
Location: KSC SAEF II
Subject: Postflight Detail of Tray A9

Figure 125 (Postflight). This close-up photograph is of the right area of the exposed test specimens. Some of the test specimens are discolored and damaged. Note the first four from the right active coating samples located on the outer radius. Two of the first three, which were originally white, now appear brown and have significant damage. The fourth active sample from the right, which was originally black, appears to have eroded, thus leaving only a trace of the paint or primer on the substrate. The passive samples, located on the inner radius, appear to have no physical damage; however, some of the white paint samples now appear brown or tan.

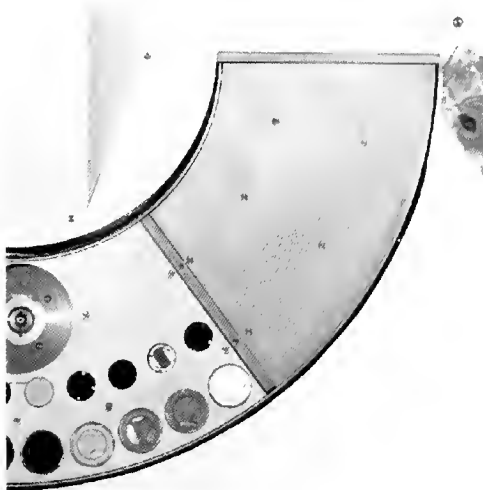
Figure 126
Photo No.: KSC-390C-1419.07
Dup. Neg. No.: L91-7719
LISAR No.: EL-1994-00379
Photo Credit: KSC
Photo Date: 2/28/90
Location: KSC SAEF II
Subject: Postflight Detail of Tray A9

Figure 126 (Postflight). This close-up of the right area of the carousel and tray bottom shows the area of damaged silvered Teflon film. Numerous discolorations from space debris impacts are also visible.

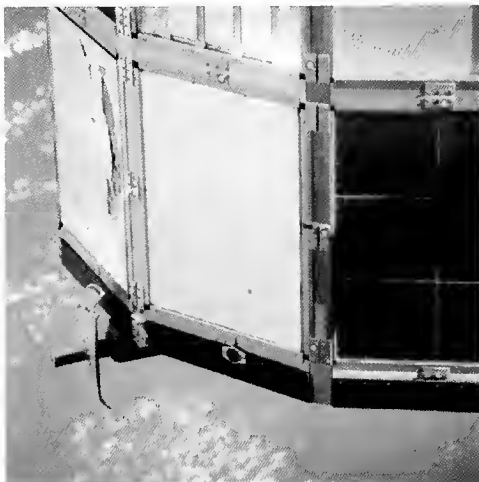
Figure 127 (In Flight). Note the dark brown stain on the LDEF structure adjacent to the edge of the black thermal panel. The thermal cover surface of experiment AO178 appears to have changed from specular to opaque with many black dots of various sizes that appear to be impact or penetration discolorations. A large discoloration is clearly visible in the lower right quadrant of the thermal cover. Many discolorations appear to be encircled by white halos. Numerous circular white discolorations that seem to be impacts are visible on the surface of the cover. The cover appears to be more taut than in the prelaunch photograph and the locations of Velcro attachment pads are apparent. The ground strap appears to be in place and to have no visible damage, but it appears to be a darker color.

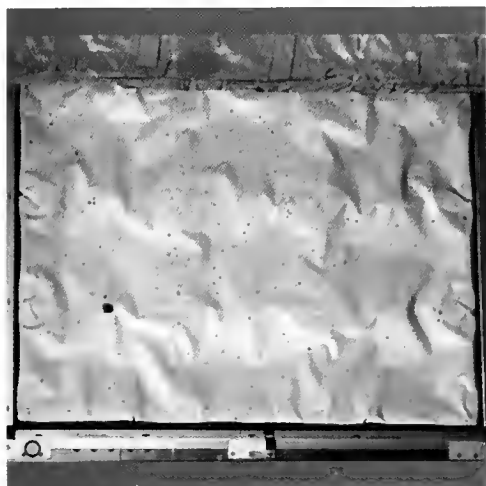
Figure 128
Photo No.: KSC-390C-612.01
Dup. Neg.: L92-17792
LISAR No.: EL-1994-00122
Photo Credit: KSC
Photo Date: 1/30/90
Location: KSC OPF
Subject: Postflight Survey of Tray A10

Figure 128 (Postflight). The thermal cover surface appears to have changed from specular to opaque (glossy white) with many black dots of various sizes. These black dots are probably the results of impacts or penetrations of the 5-mil Teflon film that allowed atomic oxygen to oxidize and erode the layer of vapor-deposited silver beneath. The cover is not as taut as in the in-flight photograph and locations of Velcro attachment pads are not as prominent. The ground strap appears to be in place and to have no visible damage, but it appears to be a deeper copper color. The cradled RMS arm is visible at the upper edge of the photograph.

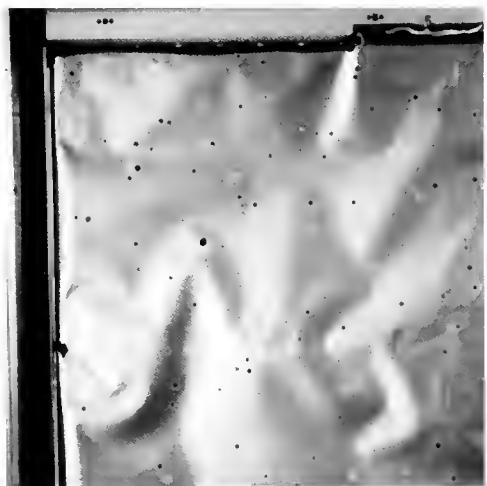
Figure 129
Photo No.: KSC-390C-2208.03
Dup Neg. No.: L91-7776
LISAR No.: EL-1994-00509
Photo Credit: KSC
Photo Date: 3/22/90
Location: KSC SAEF II
Subject: Postflight Detail of Upper Left of Tray A10

Figure 129 (Postflight). This close-up photograph of the upper left one-sixth of the tray shows numerous space debris impact or penetration discolorations. White dots of various sizes are visible on the cover and many appear to be encircling impact locations. The silvered Teflon film surface appears diffuse rather than specular as it was in preflight photographs.

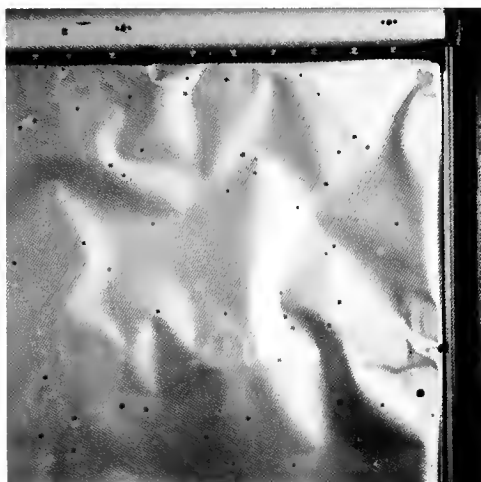
Figure 131
Photo No.: KSC-390C-2208.05
Dup. Neg. No.: L91-7778
LISAR No.: EL-1994-00530
Photo Credit: KSC
Photo Date: 3/22/90
Location: KSC SAEF II
Subject: Postflight Detail of Upper Right of
Tray A10

Figure 131 (Postflight). This photograph is of the upper right one-sixth of the tray. It shows numerous space debris impact or penetration discolorations. White dots of various sizes are visible on the cover and many seem to be encircling impact locations. The silvered Teflon film surface appears diffuse rather than specular as it was in preflight photographs.

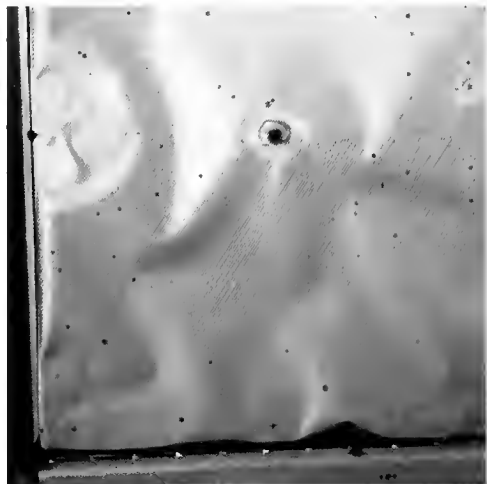
Figure 132
Photo No.: KSC-390C-2208.09
Dup. Neg. No.: L91-7782
LISAR No.: EL-1994-00531
Photo Credit: KSC
Photo Date: 3/22/90
Location: KSC SAEF II
Subject: Postflight Detail of Lower Left of Tray A10

Figure 132 (Postflight). This photograph is of the lower left one-sixth of the tray. It shows numerous space debris impact or penetration discolorations. White dots of various sizes are visible on the cover and many appear to be encircling impact locations. The silvered Teflon film surface appears diffuse rather than specular as it was in preflight photographs. One large discoloration spot is in the upper center of the photograph.

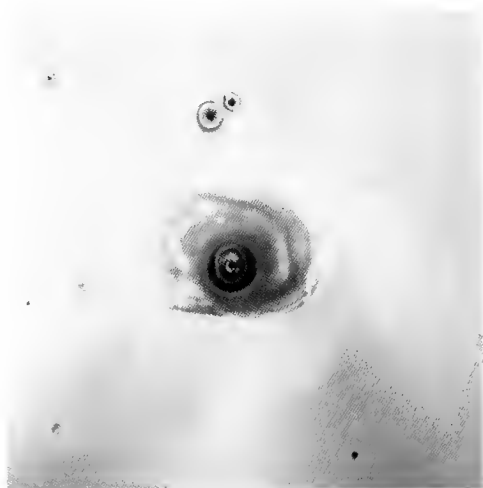
Figure 135
Photo No.: KSC-390C-2208.12
Dup. Neg. No.: L91-7785
LISAR No.: EL-1994-00534
Photo Credit: KSC
Photo Date: 3/22/90
Location: KSC SAEF II
Subject: Postflight Detail of Impact or Penetration in
Tray A10

Figure 135 (Postflight). This close-up photograph is of the large discolored impact or penetration located in the lower left one-sixth of the tray. A large lighter area of discoloration surrounds the darker area. The upper left side of the photograph is light because of photographic lights.

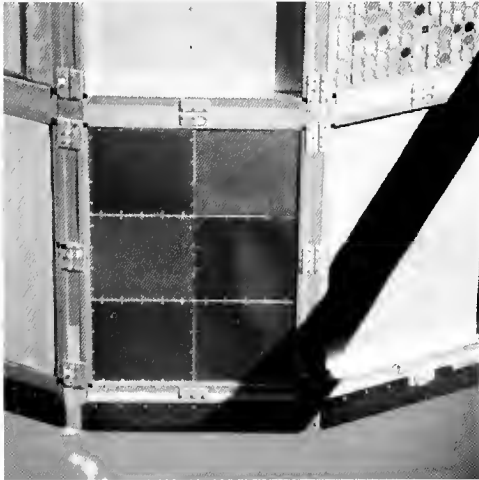
Figure 137
Photo No.: S32-78-058
Dup. Neg. No.: L90-10438
LISAR No.: EL-1994-00013
Photo Credit: JSC
Photo Date: 1/12/90
Location: In Flight
Subject: In-Flight Survey of Tray A11

Figure 137 (In Flight). The experiment appears to be intact. Impact craters, which appear as small white imperfections in the dark blue background, are visible on all six detector plates. The apparent dark blue of the aluminum detector panels in this photograph is the result of the lighting and the camera angle.

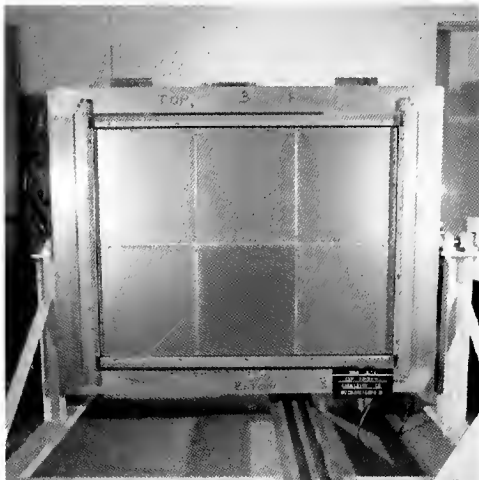
Figure 138
Photo No.: KSC-390C-1697.10
Dup. Neg. No.: L91-7805
LISAR No.: EL-1994-00263
Photo Credit: KSC
Photo Date: 3/7/90
Location: KSC SAEF II
Subject: Postflight Survey of Tray A11

Figure 138 (Postflight). Close inspection of the postflight photograph reveals tiny white spots on the detector plates where impacts have occurred during flight. The largest impact appears to have been on the plate in the lower left corner of the experiment tray.

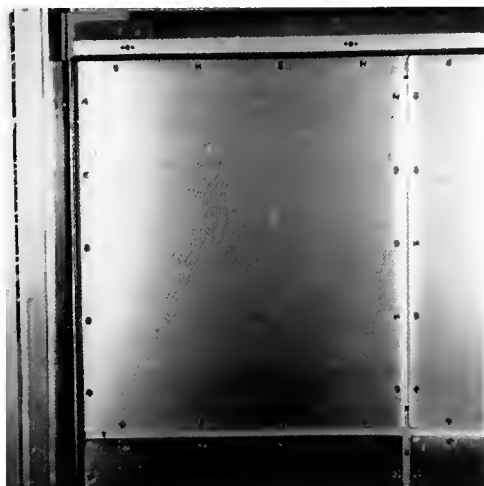
Figure 139
Photo No.: KSC-390C-1697.11
Dup. Neg. No.: L91-7806
LISAR No.: EL-1994-00228
Photo Credit: KSC
Photo Date: 3/7/90
Location: KSC SAEF II
Subject: Postflight Detail of Upper Left Plate of
Tray A11

Figure 139 (Postflight). This close-up photograph is of the upper left plate. The very small white dots are impact craters. The lighter area to the left is a result of photographic light reflections.

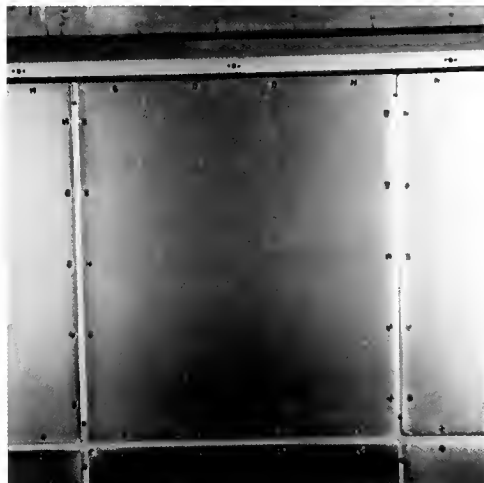
Figure 140
Photo No.: KSC-390C-1697.12
Dup. Neg. No.: L91-7807
LISAR No.: EL-1994-00229
Photo Credit: KSC
Photo Date: 3/7/90
Location: KSC SAEF II
Subject: Postflight Detail of Upper Center Plate of
Tray A11

Figure 140 (Postflight). This close-up photograph is of the upper center plate. The very small white dots are impact craters.

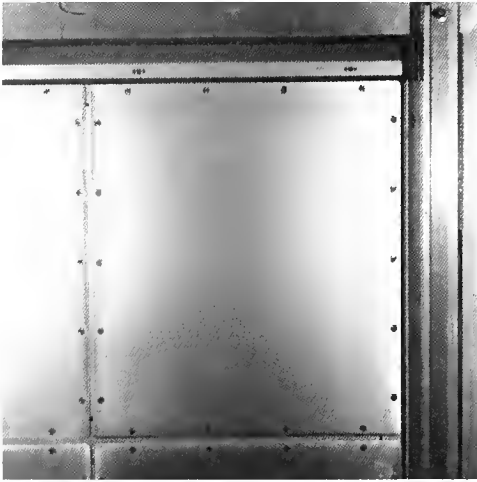
Figure 141 (Postflight). This close-up photograph is of the upper right plate. The very small white dots are impact craters.

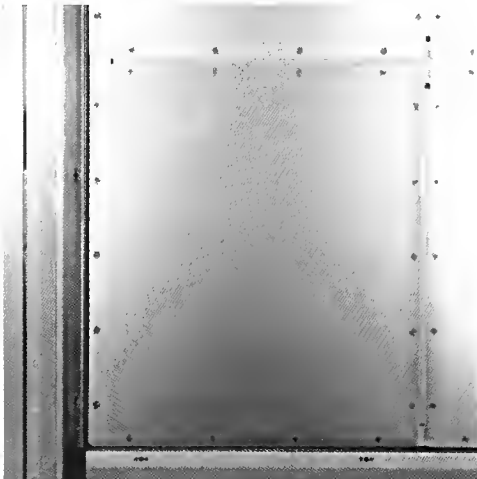
Figure 142 (Postflight). This close-up photograph is of the lower left plate. The very small white dots are impact craters. The upper left has what appears to be a bulge in the panel. This bulge can be found in preflight photographs and is not a result of flight.

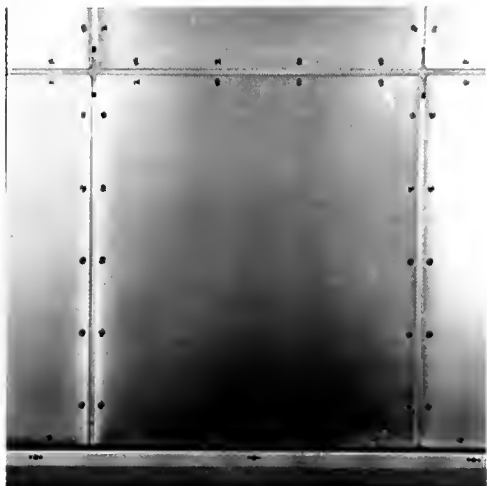
Figure 143
Photo No.: KSC-390C-1699.04
Dup. Neg. No.: L91-7817
LISAR No.: EL-1994-00232
Photo Credit: KSC
Photo Date: 3/7/90
Location: KSC SAEF II
Subject: Postflight Detail of Lower Center Plate of
Tray A11

Figure 143 (Postflight). This close-up photograph is of the lower center plate. The very small white dots are impact craters.

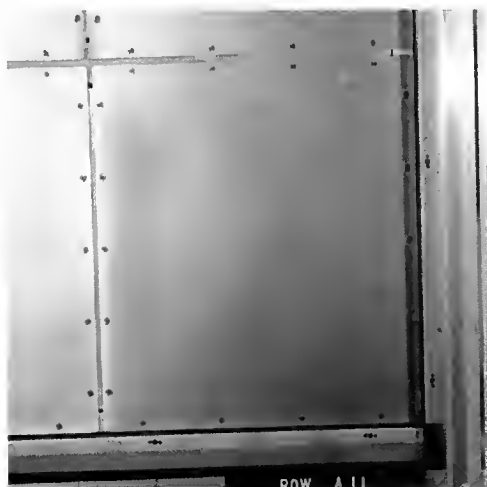
Figure 144
Photo No.: KSC-390C-1699.05
Dup. Neg. No.: L91-7818
LISAR No.: EL-1994-00233
Photo Credit: KSC
Photo Date: 3/7/90
Location: KSC SAEF II
Subject: Postflight Detail of Lower Right Plate of
Tray A11

Figure 144 (Postflight). This close-up photograph is of the lower right plate. The very small white dots are impact craters. The left part of the photograph shows photographic light reflections.

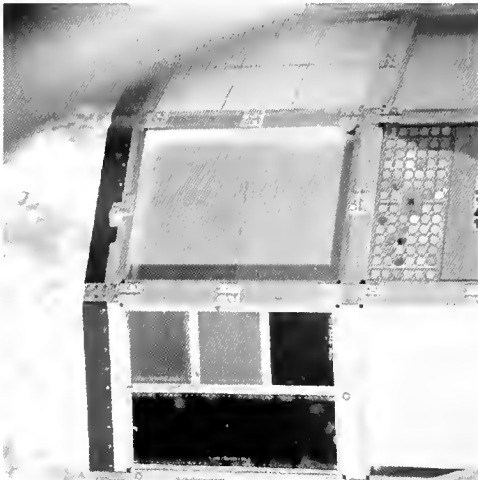
Figure 145 (In Flight). The greenish-gray tint on the two debris panels is the by-product of the chromic anodization coating process. The blue tint can be attributed to reflections of the sky. The vertical streaks on the debris panels are by-products of chromic anodizing; these streaks have been enhanced by the blue reflection. Brown stains are located along the left edge of the right debris panel. An irregular discoloration extends horizontally across the lower half of the left debris panel. The light band along the vertical edge of the left debris panel and across the top of both debris panels is a reflection from the tray sidewall.

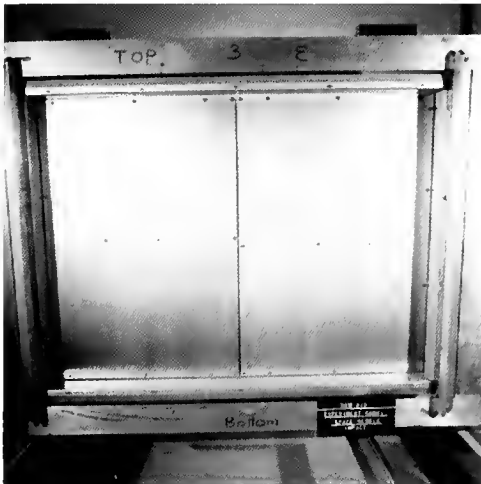
Figure 146
Photo No.: KSC-390C-2163.03
Dup. Neg.: L91-7828
LISAR No.: EL-1994-00472
Photo Credit: KSC
Photo Date: 3/21/90
Location: KSC SAEF II
Subject: Postflight Survey of Tray A12

Figure 146 (Postflight). The pink and greenish-gray tints on the two debris panels are by-products of the chromic anodization coating process and are not attributed to contamination or exposure to the space environment. The vertical streaks observed on the right debris panel in the in-flight photograph are still visible, although they are not as distinct. The irregular discoloration extending horizontally across the left debris panel remains well defined. The light band across the top and bottom of the debris panels is caused by light reflecting from the tray sidewalls.

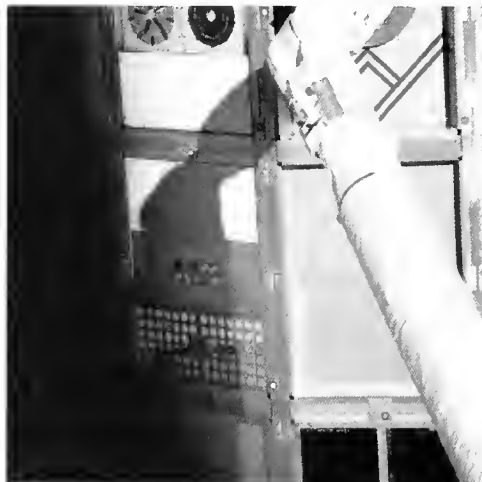
Figure 147 (In Flight). The pink and greenish-gray tints on the two debris panels are by-products of the chromic anodization coating process and are not attributed to contamination or exposure to the space environment.

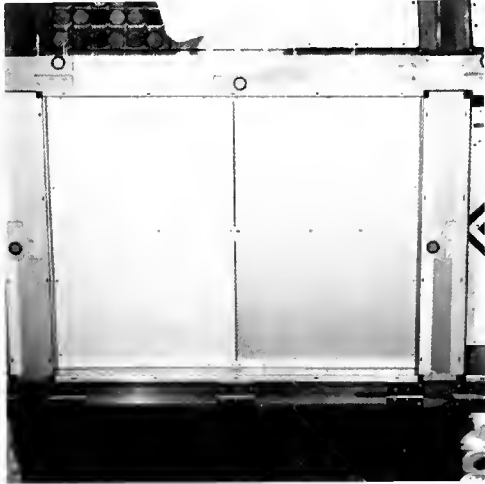
Figure 148
Photo No.: KSC-390C-1066.11
Dup. Neg. No.: L90-13480
LISAR No.: EL-1994-00189
Photo Credit: KSC
Photo Date: 2/8/90
Location: KSC SAEF II
Subject: Postflight Survey of Tray B1

Figure 148 (Postflight). The pink and greenish-gray tints on the two debris panels are by-products of the chromic anodization coating process and are not attributed to contamination or exposure to the space environment. The light bands along the bottom and the left and right edges of the panels are caused by lights reflecting from the tray sidewalls. The two small mounds on the panel on the left are manufacturing defects that existed prior to flight. Markings along the top of the photograph are the result of film processing.

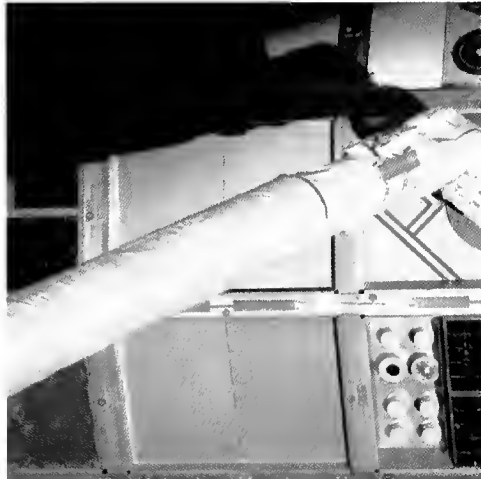
Figure 149 (In Flight). The greenish-gray tint on the left debris panels and the pink tint on the right debris panel are by-products of the chromic anodization coating process. The light band along the left side and across the bottom of the panels is caused by light reflecting from the tray sidewalls.

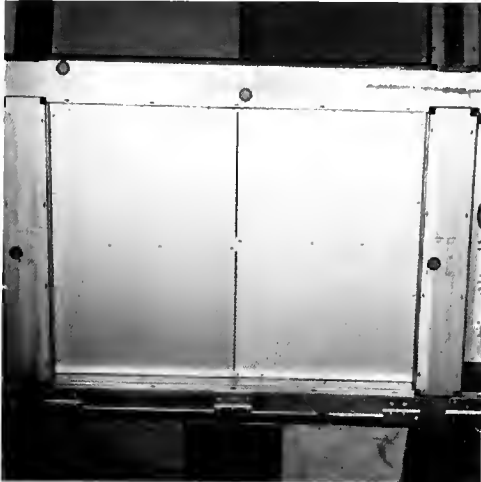
Figure 150
Photo No.: KSC-390C-1066.05
Dup. Neg. No.: L90-13474
LISAR No.: EL-1994-00386
Photo Credit: KSC
Photo Date: 2/8/90
Location: KSC SAEF II
Subject: Postflight Survey of Tray B2

Figure 150 (Postflight). The pink and greenish-gray tints on the two debris panels are by-products of the chromic anodization coating process and are not attributed to contamination or exposure to the space environment. The light band along the sides and across the bottom of the panels is caused by light reflecting from the tray sidewalls.

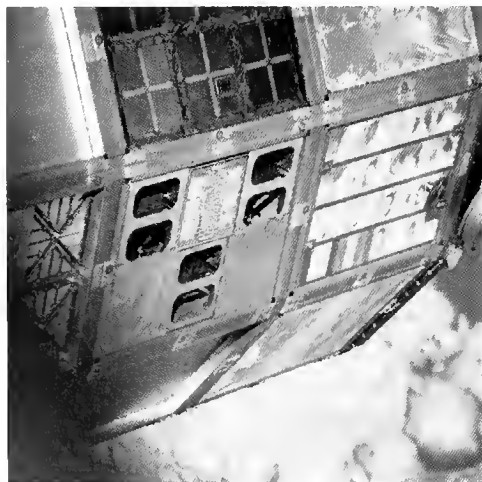
Figure 152 (In Flight). The experiment appears to be without physical damage except for a tear in the material behind the Teflon and glass thermal cover in the lower left corner. Both the mounting plate of the experiment AO138-1 and the plates that provide masks for the open canisters seals have stained surfaces. The exposed experiment mounting plate, however, appears to have a much darker discoloration. The material samples on the top corners of the two upper plates that provide masks for the open canister seals do not appear to be discolored.

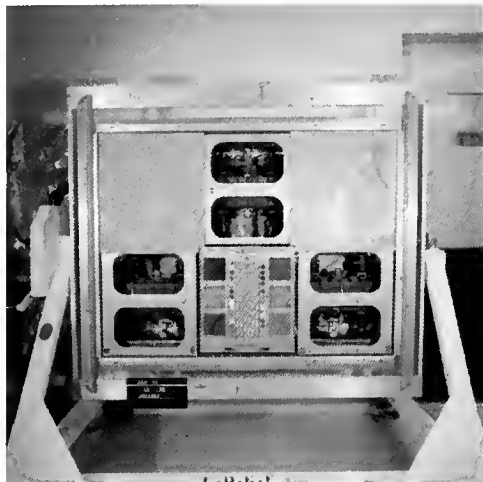
Figure 153
Photo No.: KSC-390C-1646.09
Dup. Neg. No.: L91-7874
LISAR No.: EL-1994-00217
Photo Credit: KSC
Photo Date: 3/6/90
Location: KSC SAEF II
Subject: Postflight Survey of Tray B3

Figure 153 (Postflight). The experiment appears to have no physical damage except for a tear in thermal cover and some discolored areas. The material samples on the bottom corners of the two lower canister cover plates do not appear to be discolored.

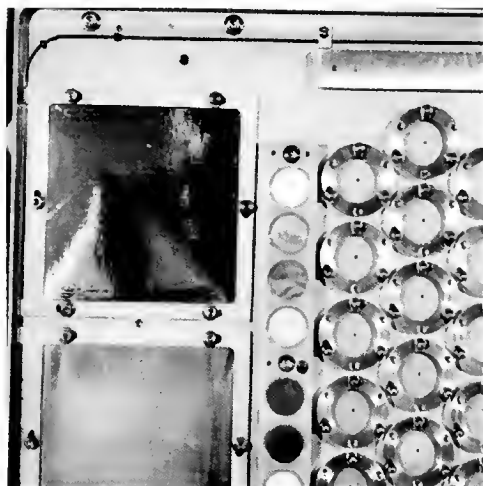
Figure 154
Photo No.: KSC-390C-1648.08
Dup. Neg. No.: L91-7895
LISAR No.: EL-1994-00368
Photo Credit: KSC
Photo Date: 3/6/90
Location: KSC SAEF II
Subject: Postflight Detail of Upper Left of Lower
Center of Tray B3

Figure 154 (Postflight). This close-up of the upper left of the lower center of the tray shows that the experiment mounting plate has a darker color than before flight. The test samples appear wrinkled but are intact.

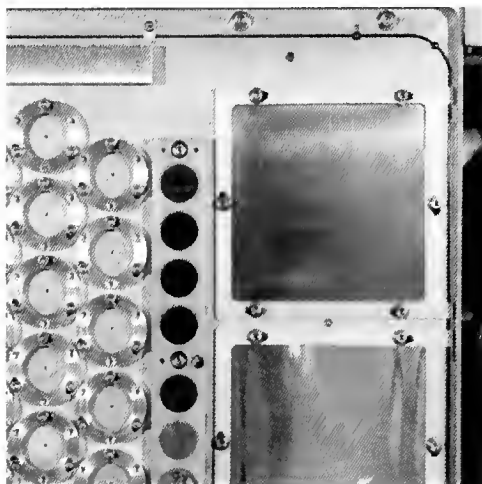
Figure 155 (Postflight). This close-up of the upper right of the lower center of the tray shows that the experiment mounting plate has a darker color than before flight.

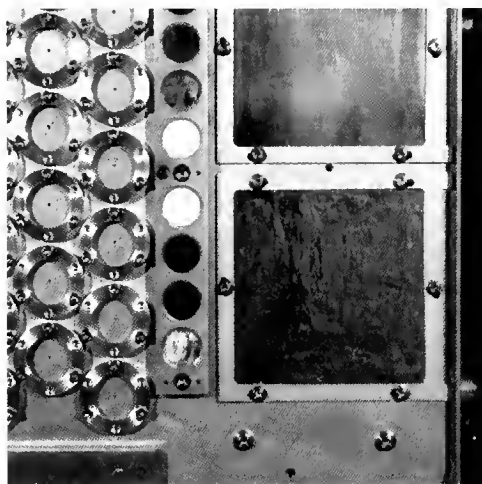
Figure 156 (Postflight). This close-up of the lower right of the lower center of the tray shows that the experiment mounting plate has a darker color than before flight. The test samples appear intact.

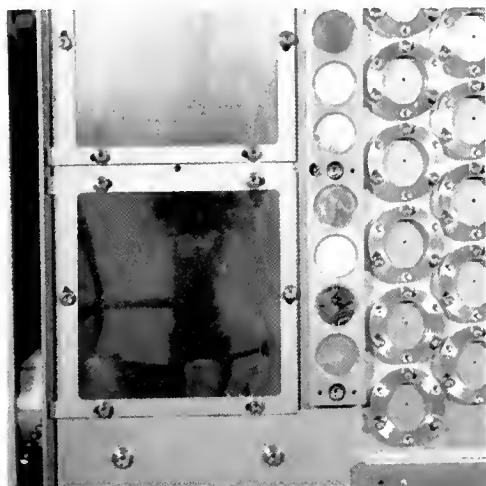
Figure 157 (Postflight). This close-up of the lower left of the lower center tray shows that the experiment mounting plate is a darker color than before flight. The test samples appear wrinkled but are intact.

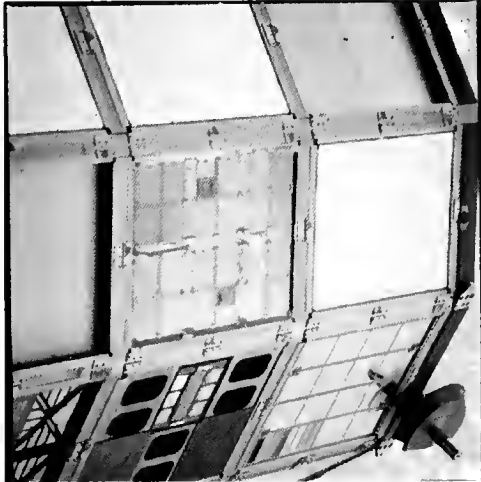
Figure 159
Photo No.: S32-77-027
Dup. Neg.: L90-10407
LISAR No.: EL-1994-00090
Photo Credit: JSC
Photo Date: 1/12/90
Location: In Flight
Subject: In-Flight Survey of Tray B4

Figure 159 (In Flight). The experiment appears to have no physical damage from exposure to the space environment. The lighting is such that changes in material colors are difficult to detect; however, the white paint in the vicinity of the solar cell modules appears to have darkened.

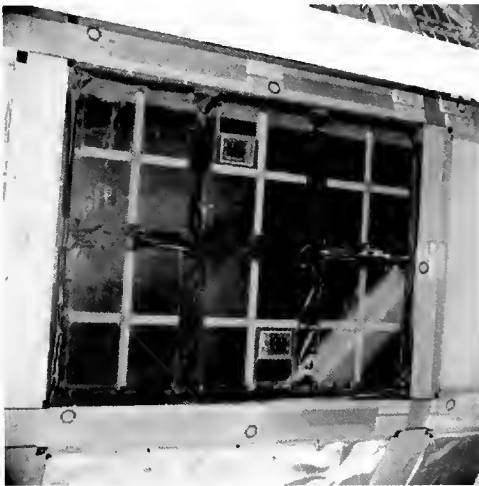
Figure 160
Photo No.: KSC-390C-730.08
Dup. Neg. No.: L92-17647
LISAR No.: EL-1994-00164
Photo Credit: KSC
Photo Date: 2/1/90
Location: KSC O & C building
Subject: Postflight Survey of Tray B4

Figure 160 (Postflight). The experiment appears to be without physical damage. The white paint around the outer edges of the solar cell modules seems to have changed to a light tan.

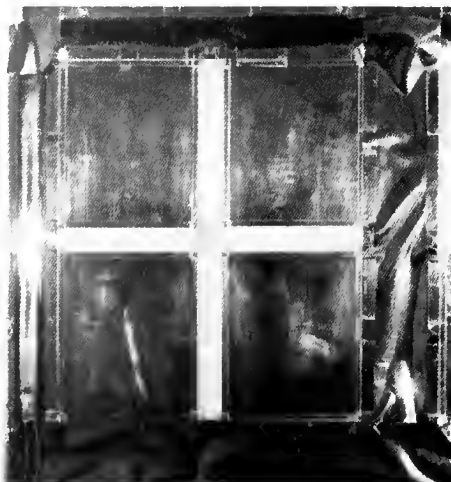
Figure 161 (Postflight). This photograph of the upper left one-sixth of the tray shows that the experiment has no apparent physical damage. Surfaces remain highly reflective.

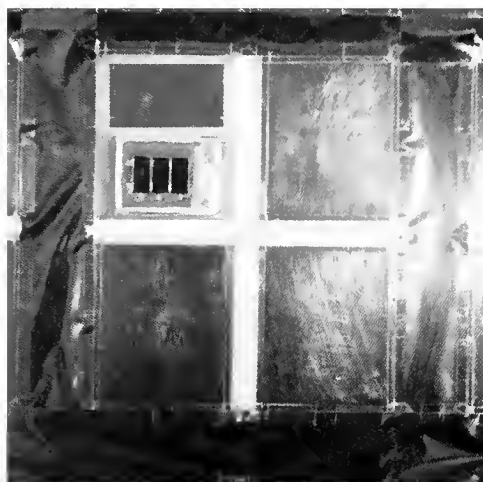
Figure 162 (Postflight). This photograph of the upper center one-sixth of the tray shows that the experiment has no apparent physical damage. Surfaces remain highly reflective. The white paint around the outer edges of the solar cell modules appears to have changed to a light tan.

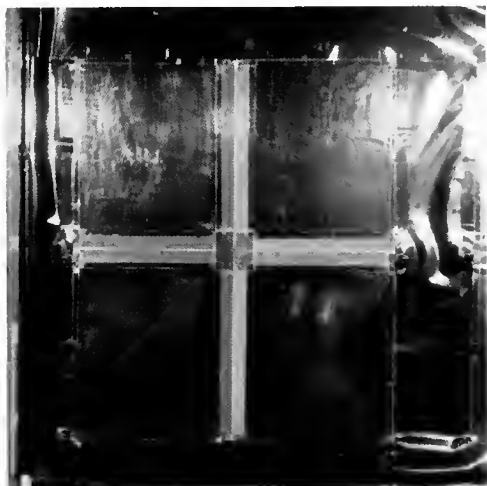
Figure 164
Photo No.: KSC-390C-2117.05
Dup. Neg. No.: L91-7933
LISAR No.: EL-1994-00500
Photo Credit: KSC
Photo Date: 3/20/90
Location: KSC SAEF II
Subject: Postflight Detail of Lower Left of Tray B4

Figure 164 (Postflight). This photograph is of the lower left one-sixth of the tray. It shows the experiment with no apparent physical damage. Surfaces remain highly reflective.

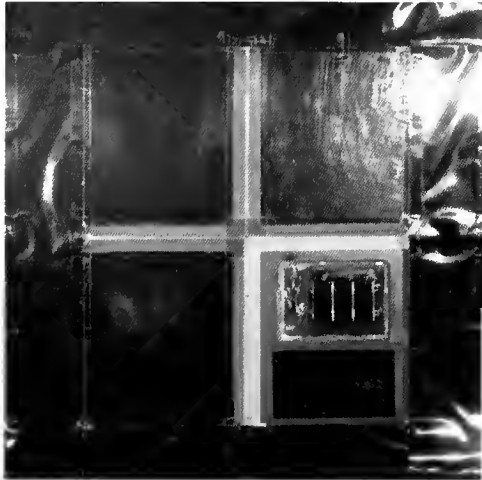
Figure 165 (Postflight). This photograph is of the lower center one-sixth of the tray. It shows the experiment with no apparent physical damage. Surfaces remain highly reflective. The white paint around the outer edges of the solar cell modules has changed to a light tan.

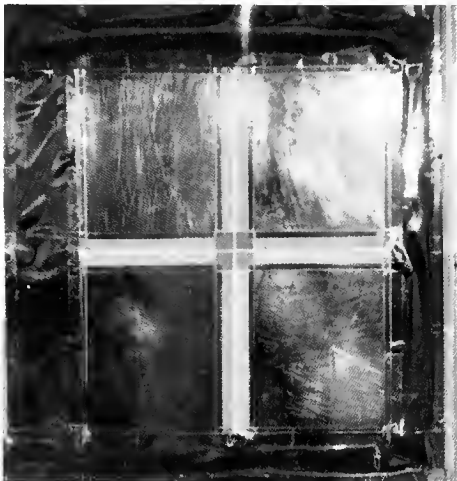
Figure 166 (Postflight). This photograph is of the lower right one-sixth of the tray. It shows the experiment without apparent physical damage. Surfaces remain highly reflective.

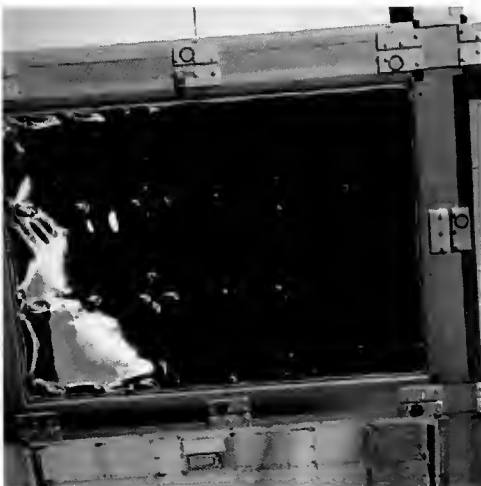
Figure 167 (In Flight). The thermal cover has no apparent damage; however, it is more taut than in the prelaunch photograph. The glossy black appearance of the thermal cover is due to lighting conditions and not to a change in the material optical properties. The bright spots on the dark thermal cover background are areas where Velcro pads are bonded to the back of the cover. The large bright area on the left of the cover is reflected light. The scalloped edge across the top, bottom, and left side of the cover occurs between attachment pads. The ground strap is in place with no visible damage.

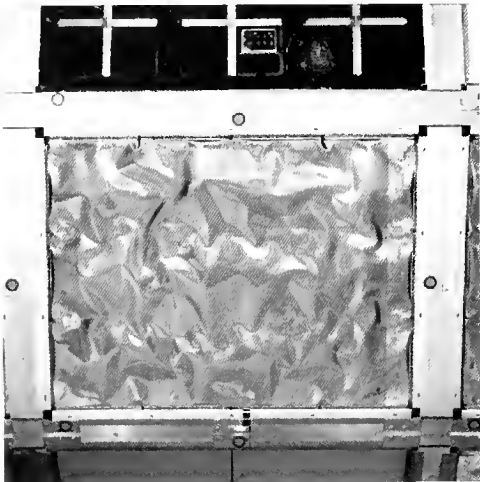
Figure 168
Photo No.: KSC-390C-1035.08
Dup. Neg. No.: L90-13453
LISAR No.: EL-1994-00184
Photo Credit: KSC
Photo Date: 2/9/90
Location: KSC SAEF II
Subject: Postflight Survey of Tray B5

Figure 168 (Postflight). The thermal cover appears to be specular with no apparent damage. The cover is less taut than in the in-flight photograph and the locations of Velcro attachment pads are not as prominent. The scallop effect around the cover edges occurs between the attachment pads and shows the upper edge of the support frame. The ground strap is in place with no visible damage.

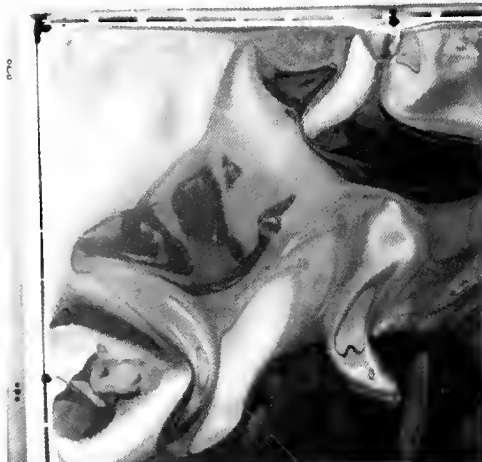
Figure 169
Photo No.: KSC-390C-2151.05
Dup. Neg. No.: L91-7974
LISAR No.: EL-1994-00513
Photo Credit: KSC
Photo Date: 3/21/90
Location: KSC SAEF II
Subject: Postflight Detail of Upper Left of Thermal Cover of Tray B5

Figure 169 (Postflight). This photograph is of the upper left one-sixth of the tray. The thermal cover appears specular with no apparent damage. The reflective properties of the uneven surface of the cover result in various light and color patterns. A few impact or penetration discolorations are visible.

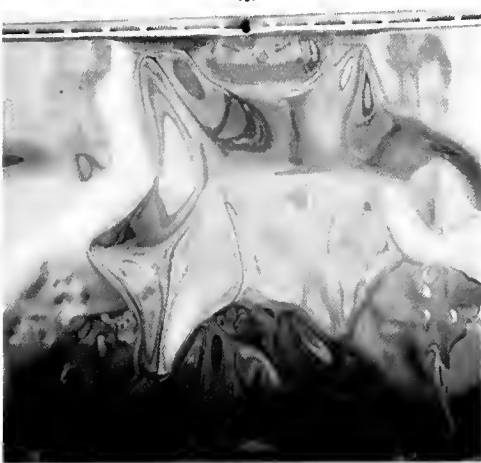
Figure 170
Photo No: KSC-390C-2151.06
Dup. Neg. No.: L91-7975
LISAR No.: EL-1994-00514
Photo Credit: KSC
Photo Date: 3/21/90
Location: KSC SAEF II
Subject: Postflight Detail of Upper Center of
Thermal Cover of Tray B5

Figure 170 (Postflight). This photograph is of the upper center one-sixth of the tray. The thermal cover appears specular with no apparent damage. The reflective properties of the uneven surface of the cover result in various light and color patterns. A few impact or penetration discolorations are visible.

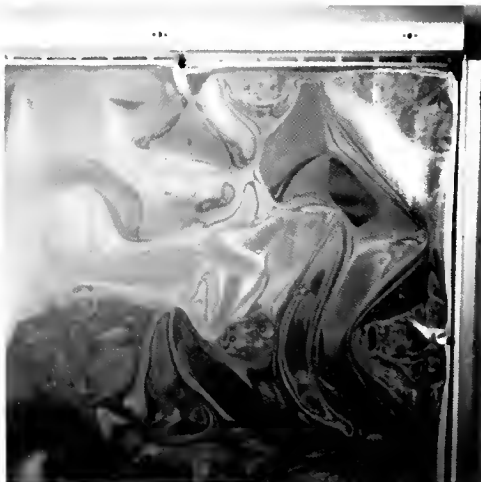
Figure 171
Photo No.: KSC-390C-2151.07
Dup. Neg. No.: L91-7976
LISAR No.: EL-1994-00515
Photo Credit: KSC
Photo Date: 3/21/90
Location: KSC SAEF II
Subject: Postflight Detail of Upper Right of Thermal
Cover of Tray B5

Figure 171 (Postflight). This photograph is of the upper right one-sixth of the tray. The pattern enhanced by reflected light in the upper right corner of the thermal cover existed during preflight and was not due to space exposure. The thermal cover appears specular with no apparent damage. The reflective properties of the uneven surface of the cover result in various light and color patterns. A few impact or penetration discolorations are visible.

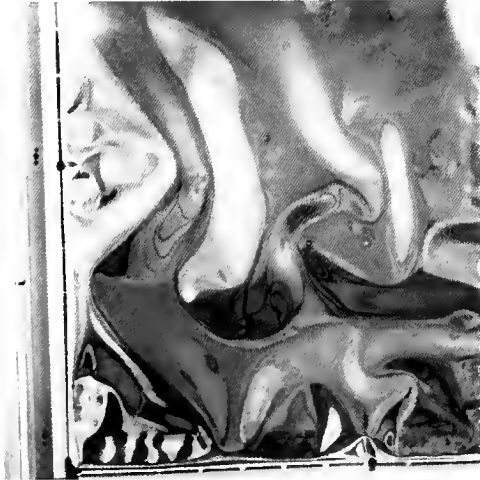
Figure 172 (Postflight). This photograph is of the lower left one-sixth of the tray. The thermal cover appears specular with no apparent damage. The reflective properties of the uneven surface of the cover result in various light and color patterns. A few impact or penetration discolorations are visible.

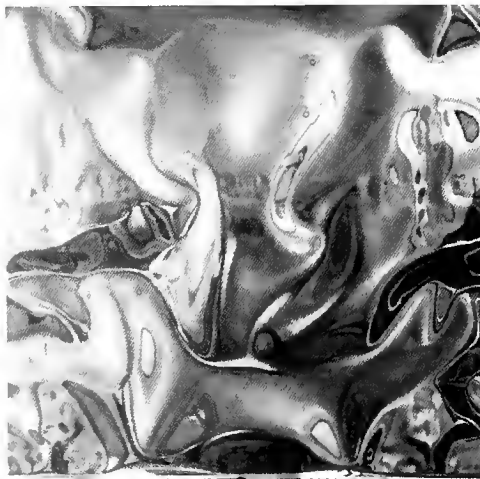
Figure 173 (Postflight). This photograph is of the lower center one-sixth of the tray. The thermal cover appears specular with no apparent damage. The reflective properties of the uneven surface of the cover result in various light and color patterns. A few impact or penetration discolorations are visible.

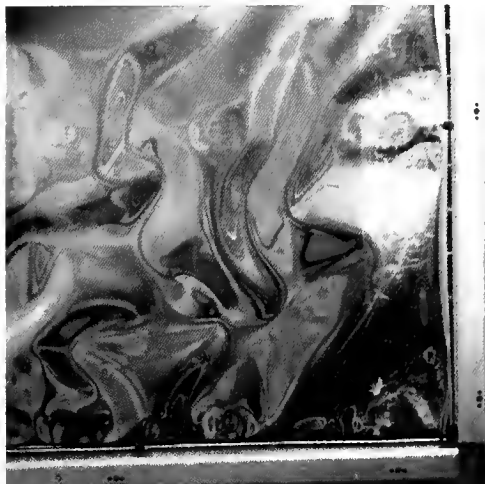
Figure 174 (Postflight). This photograph is of the lower right one-sixth of the tray. The pattern enhanced by reflected light along the right edge of the thermal cover existed preflight and was not due to space exposure. The thermal cover appears specular with no apparent damage. The reflective properties of the uneven surface of the cover result in various light and color patterns. A few impact or penetration discolorations are visible.

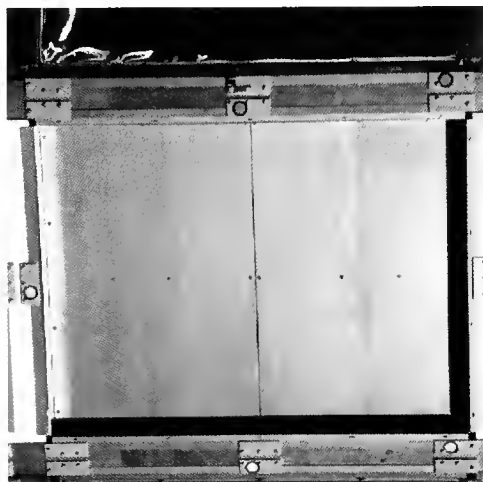
Figure 175 (In Flight). A portion of the greenish-gray tint on the two debris panels is the product of the chromic anodization coating process; however, a large part can be attributed to reflections of the blue sky. The vertical streaks on the panels are products of chromic anodizing that have been enhanced significantly by the blue reflection. Fingerprints along the center edges of the debris panels occurred during experiment assembly and indicate improper pre-flight handling or cleaning.

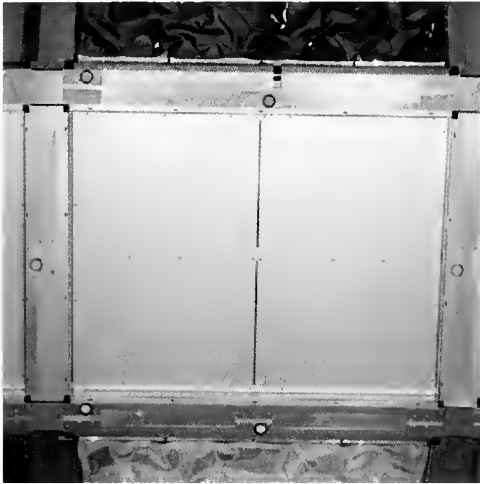
Figure 176
Photo No.: KSC-390C-1146.03
Dup. Neg. No.: L90-13505
LISAR No.: EL-1994-00192
Photo Credit: KSC
Photo Date: 2/18/90
Location: SAEF II at KSC
Subject: Postflight Survey of Tray B6

Figure 176 (Postflight). The pink and greenish-gray tints on the two debris panels are by-products of the chromic anodization coating process and are not attributed to contamination or exposure to the space environment. The fingerprints along the inner edges of the debris panels that were observed in the in-flight photograph are still visible. The dark vertical streaks on the debris panels in the in-flight photographs are almost invisible because the reflection of the sky is not present. The light band along the sides and across the bottom of the panels is caused by light reflecting from the tray sidewalls.

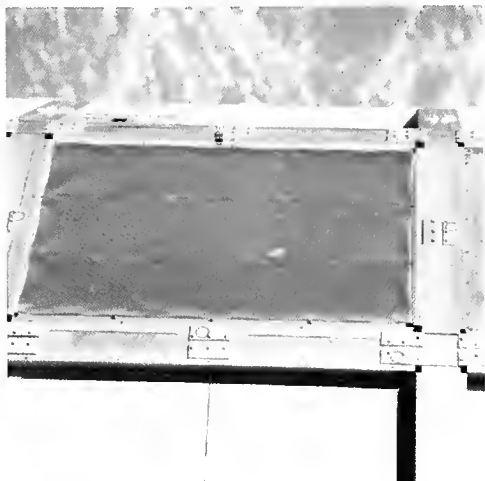
Figure 177 (In Flight). The thermal cover appears to have no apparent damage, but it is more taut than in the prelaunch photograph. The dark blue appearance of the thermal cover in this photograph is caused by lighting conditions and is not due to a change in the optical properties of the material. The oblong indentations on the thermal cover are areas where Velcro pads are bonded to the back of the cover. The surface of the thermal cover appears to have small brown circular discolorations of various sizes that appear to result from impacts or penetrations. A large light blue area of discoloration is clearly visible in the lower right quadrant of the thermal cover. The discoloration is probably the result of an impact penetrating the 5-mil Teflon film and upsetting the layer of vapor-deposited silver beneath. The scalloped edge along the left side of the thermal cover occurs between attachment pads. The ground strap appears to be in place with no visible damage, but it appears to be a deeper copper color than in the pre-launch photograph.

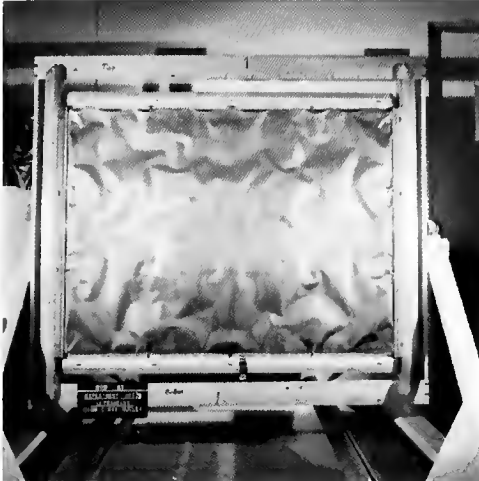
Figure 178
Photo No.: KSC-390C-2306.09
Dup. Neg. No.: L91-8035
LISAR No.: EL-1994-00312
Photo Credit: KSC
Photo Date: 3/26/90
Location: KSC SAEF II
Subject: Postflight Survey of Tray B7

Figure 178 (Postflight). The surface of the thermal cover appears to have changed from specular to opaque with black dots of various sizes that appear to be impacts or penetrations. A large area of white discoloration is clearly visible in the upper left quadrant of the thermal cover. The discoloration is probably the result of a penetration of the 5-mil Teflon film that has affected the layer of vapor-deposited silver beneath. The cover is not as taut as in the in-flight photograph and the locations of Velcro attachment pads are not as prominent. The ground strap is in place with no visible damage, but it is a deeper copper color than in the prelaunch photograph.

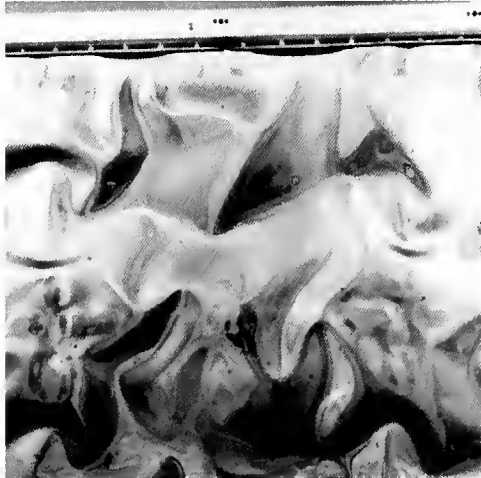
Figure 180 (Postflight). This close-up photograph is of the upper center one-sixth of the tray. The thermal cover appears to be opaque rather than specular as it was in preflight photographs. Numerous impact or penetration discolorations are visible. The thermal cover Velcro tie-down pads are also evident.

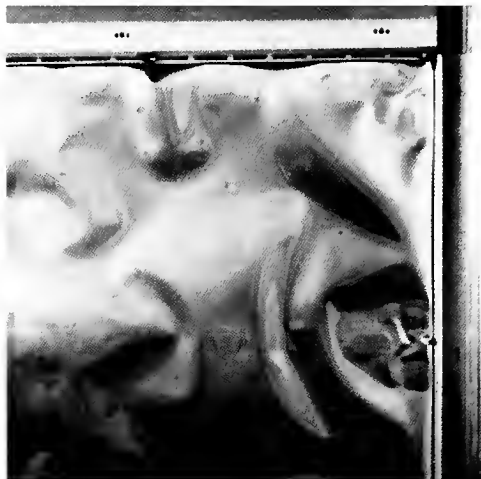
Figure 181 (Postflight). This close-up photograph is of the upper right one-sixth of the tray. The thermal cover appears to be opaque rather than specular as it was in preflight photographs. Numerous impact or penetration discolorations are visible. The thermal cover Velcro tie-down pads are also evident.

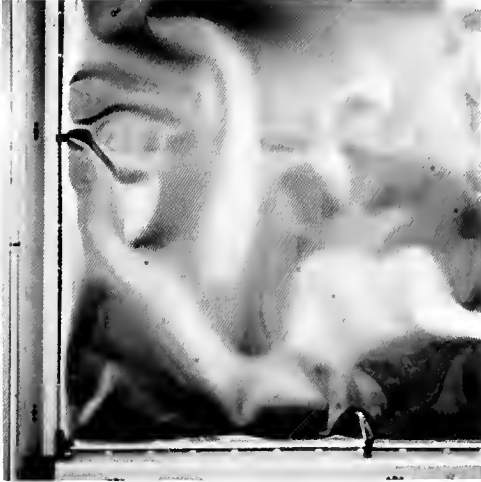
Figure 182 (Postflight). This close-up photograph is of the lower left one-sixth of the tray. The thermal cover appears to be opaque rather than specular as it was in preflight photographs. Numerous impact or penetration discolorations are visible. The thermal cover Velcro tie-down pads are also evident.

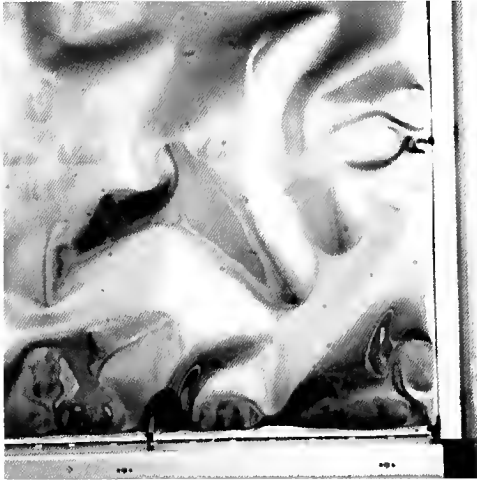
Figure 184 (Postflight). This close-up photograph is of the lower right one-sixth of the tray. The thermal cover appears to be opaque rather than specular as it was in preflight photographs. Numerous impact or penetration discolorations are visible. The thermal cover Velcro tie-down pads are also evident.

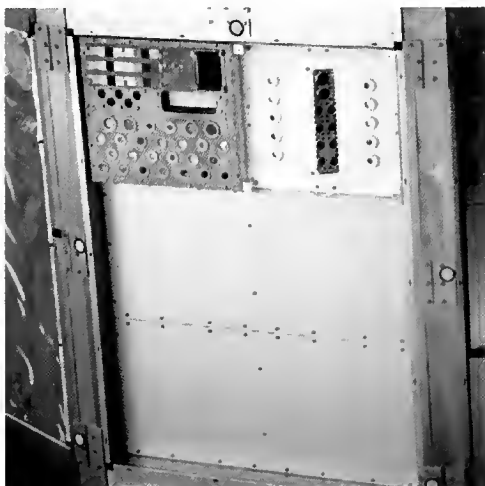
Figure 186
Photo No.: S32-76-026
Dup. Neg. No.: L90-10380
LISAR No.: EL-1994-00665
Photo Credit: JSC
Photo Date: 1/12/90
Location: In Flight
Subject: In-Flight Survey of Tray B8

Figure 186 (In Flight). Here, the space debris impact panels have a very distinct green and pink color that varies as the light angle changes across the panels. The different colors of the infrared filter surfaces of experiment AO056 may be reflections of the surrounding environment and are not from exposure to space. A brown discoloration is present on the surface of the unpainted aluminum mounting plate. Experiment AO147 appears to have no physical damage. The white paint on the aluminum mounting plate has several irregular-shaped black marks along the top edge. The marks were not visible on the prelaunch photograph.

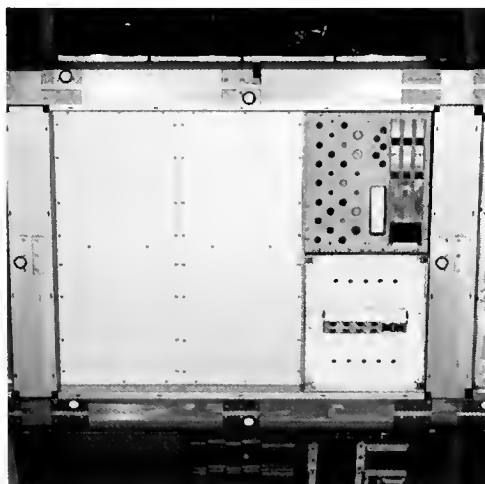
Figure 187
Photo No.: KSC-390C-1031.11
Dup. Neg. No.: L90-13421
LISAR No.: EL-1994-00146
Photo Credit: KSC
Photo Date: 2/9/90
Location: KSC SAEF II
Subject: Postflight Survey of Tray B8

Figure 187 (Postflight). Experiment AO056 appears unchanged from the in-flight photograph. The apparent blue, green, silver, and white colors of coatings and filter samples observed in the in-flight photographs are not visible. A brown discoloration is present on the surface of the unpainted aluminum mounting plate. The discoloration is darker near the fasteners around the mounting plate edges and the filter and coating holders. Experiment AO147, which is located in the lower right of the tray, appears to be without physical damage. Experiment S0001 shows the familiar green and pink that is caused by anodization.

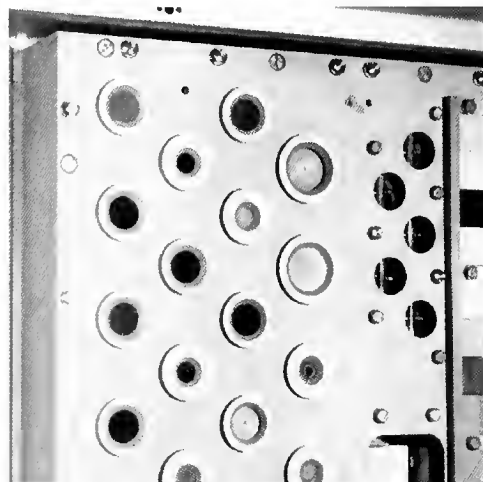
Figure 188
Photo No.: KSC-390C-1931.09
Dup. Neg. No.: L91-8064
LISAR No.: EL-1994-00431
Photo Credit: KSC
Photo Date: 3/14/90
Location: KSC SAEF II
Subject: Postflight Detail of Upper Right of Tray B8

Figure 188 (Postflight). This photograph is of the upper left one-fourth of the module for experiment AO056. The experiment is intact, but has sustained some physical damage. The experiment sample located in the second circular holder from the top in the right row appears to be missing. A brown discoloration is present on the surface of the unpainted aluminum mounting plate. The discoloration is darker near the fasteners around the mounting plate edges and the filter and coating holders.

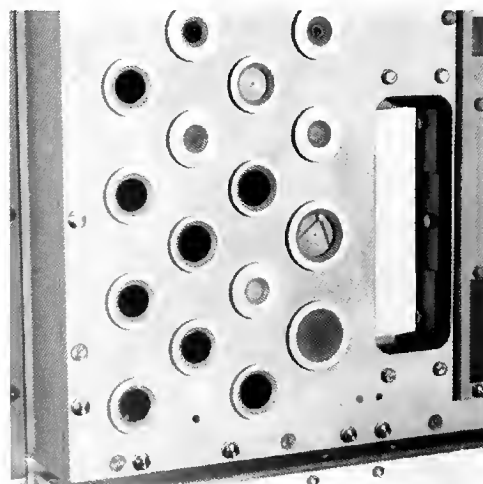
Figure 189
Photo No.: KSC-390C-1931.10
Dup. Neg.: L91-8065
LISAR No.: EL-1994-00432
Photo Credit: KSC
Photo Date: 3/14/90
Location: KSC SAEF II
Subject: Postflight Detail of Upper Right of Tray B8

Figure 189 (Postflight). This photograph is of the lower left one-fourth of the module for experiment AO056. The experiment has sustained some physical damage. An impact crater and two cracks extending outward from the crater are visible in the experiment sample mounted in the second circular holder from the bottom in the right row of filter and coating samples. A brown discoloration is present on the surface of the unpainted aluminum mounting plate and near the filter and coating holders.

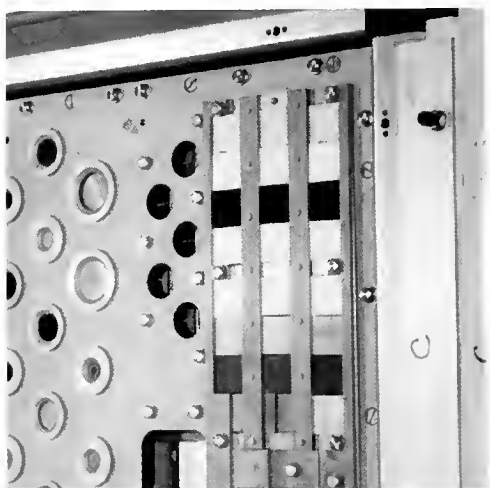
Figure 190
Photo No.: KSC-390C-1931.11
Dup. Neg. No.: L91-8066
LISAR No.: EL-1994-00433
Photo Credit: KSC
Photo Date: 3/14/90
Location: KSC SAEF II
Subject: Postflight Detail of Upper Right of Tray B8

Figure 190 (Postflight). This photograph is of the upper right one-fourth of the module for experiment AO056. The experiment is intact, but brown discolorations appear on surfaces of the Materials Technology Experiment samples that are mounted in the right half of the module.
